Technical Evaluation of the Gold King Mine Incident

San Juan County, Colorado

U.S. Department of the Interior
Bureau of Reclamation
Technical Service Center
Denver, Colorado

October 2015

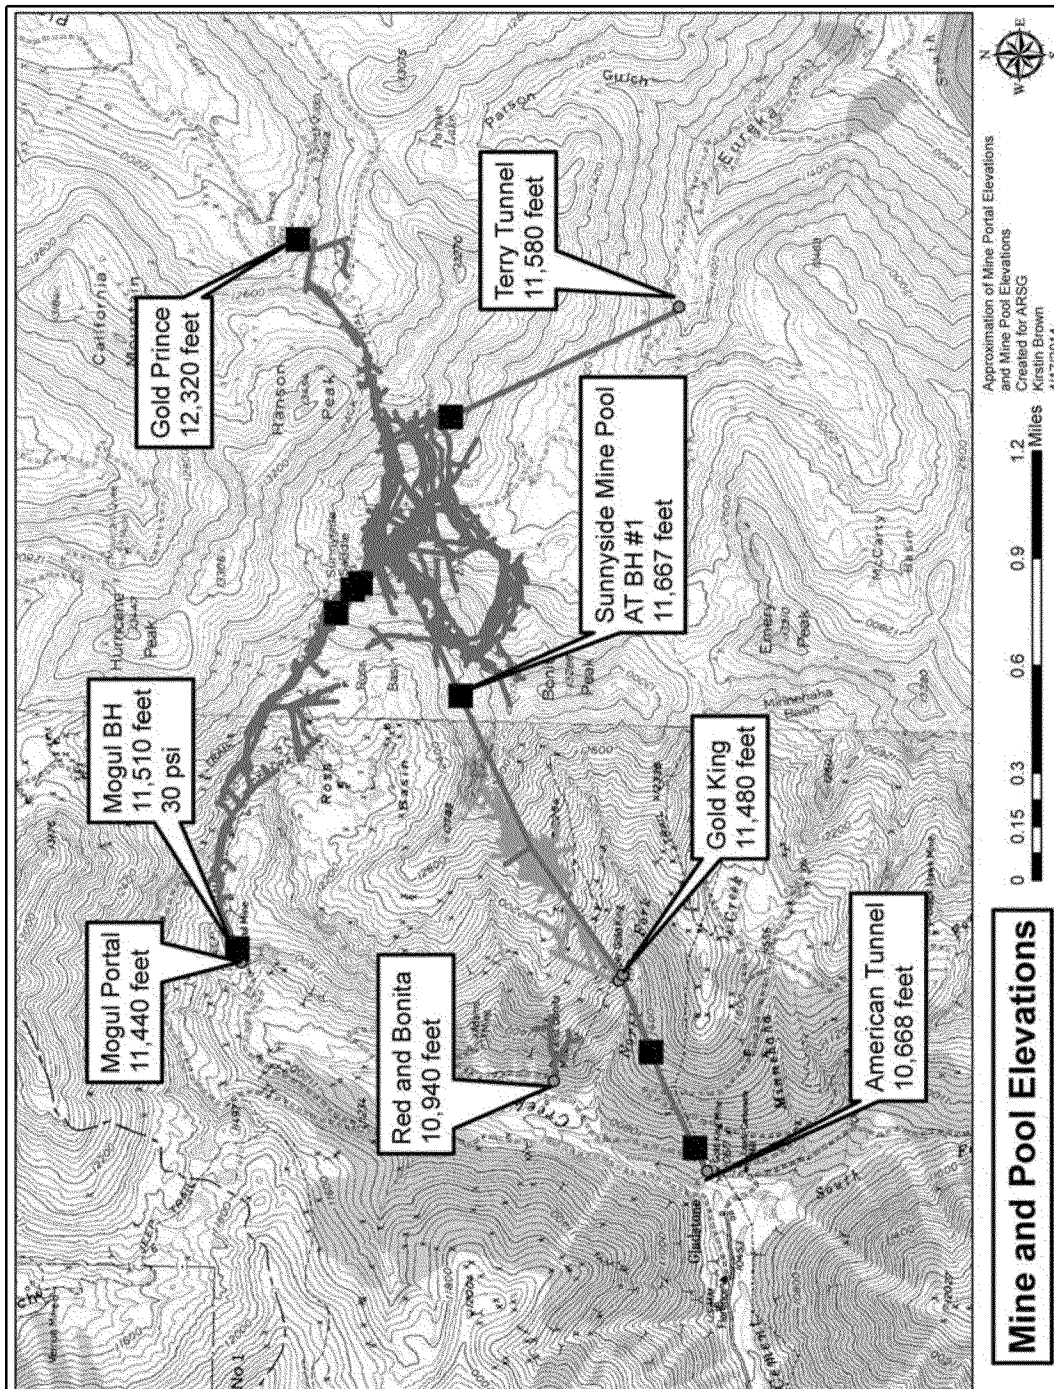
In 2000, acid drainage began discharging from the Mogul Mine. This was likely the consequence of rebounding groundwater levels and a rising mine pool caused by the installation of hydraulic bulkheads in the Sunnyside Mine. By 2002, significant flow was discharging from the Red and Bonita and the Gold King Mines Level 7 adits. In 2003, bulkheads were added to the Mogul Mine by the Sunnyside Mine owners (figures 8 through 10).

Figure 8.—Map showing topography; potentially flooded mine workings in the Sunnyside, Gold King, and Red and Bonita Mines; and the location of bulkheads (BH) represented by black squares. The approximate elevations of the mine adits are presented along with readings from the Sunnyside Mine pool (11,667 ft.) and the Mogul Mine pool (11,510 feet) (graphic prepared by Kirstin Brown of DRMS on April 17, 2014).

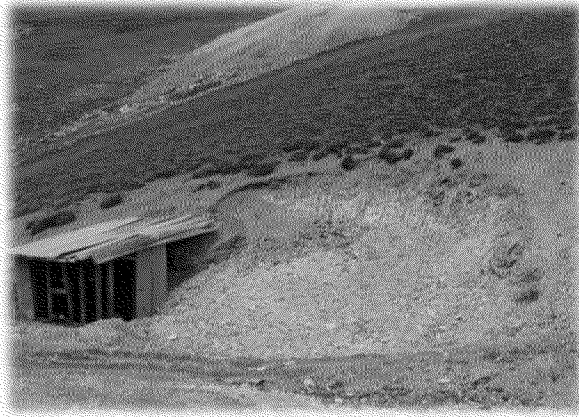
In 2009 all four permitted adits were backfilled, a flume was installed in the previously lined ditch, and 1600 feet of drill road was reclaimed. The Sampson Portal was backfilled with on-site materials and the wooden and metal debris was buried on-site. The Number One Portal was also backfilled with on-site materials and the debris from the site was buried to the east of the portal in the waste pile. In addition, a 1600 foot long drill road from the Number One Portal to immediately below the Sampson waste pile was re-contoured, ripped, mulched, and seeded.

Number 1 Portal backfilled

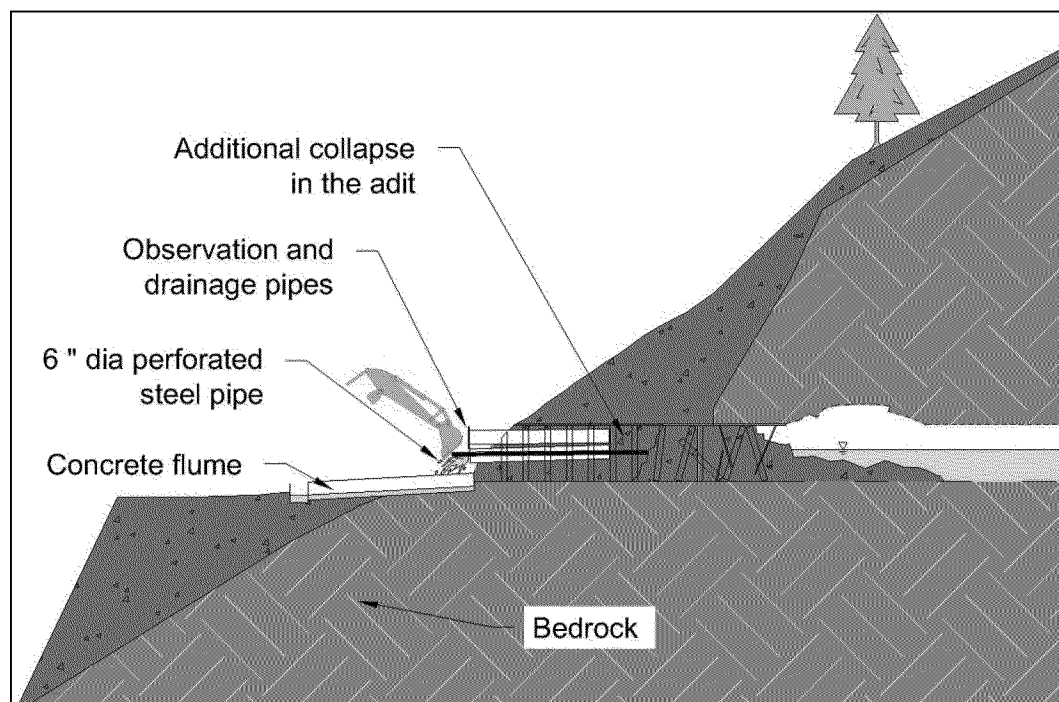
The DRMS stated in the project summary, “A future project at the site may attempt to cooperatively open the Level 7 Old Portal in an effort to alleviate the potential for an unstable increase in mine pool head within the Gold King workings.” Essentially, the closure did not provide adequate drainage and had the potential to blowout.

Figure 21.—Cross-section showing the installation of pipes by DRMS at the Gold King Mine Level 7 New Adit in 2009 (water level as assumed by DRMS) (not to scale).

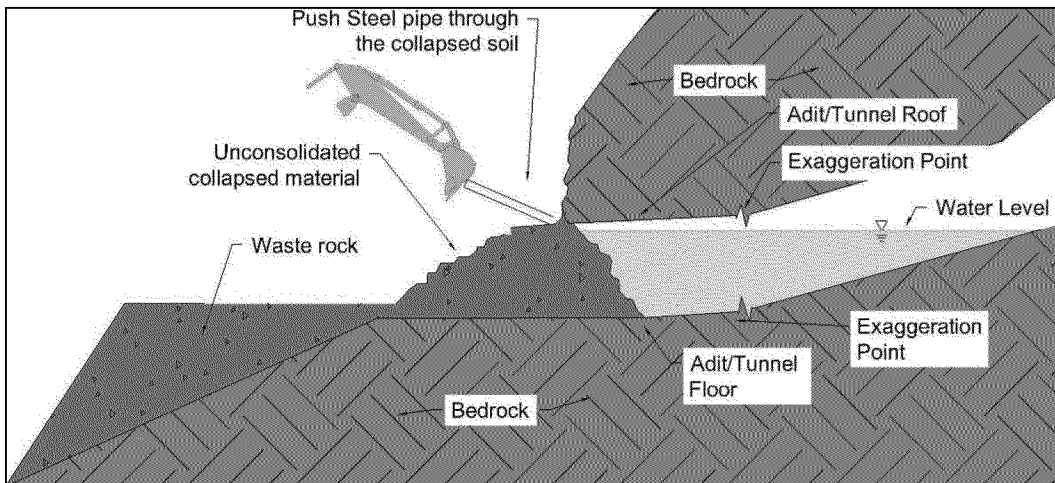
Figure 42.—Cross-section illustration showing step 2 of the plan (not to scale). With the bedrock above the crown of the adit exposed as a guide, a steel pipe called a “stinger” is positioned and pushed into the fill using the bucket of the hydraulic excavator.

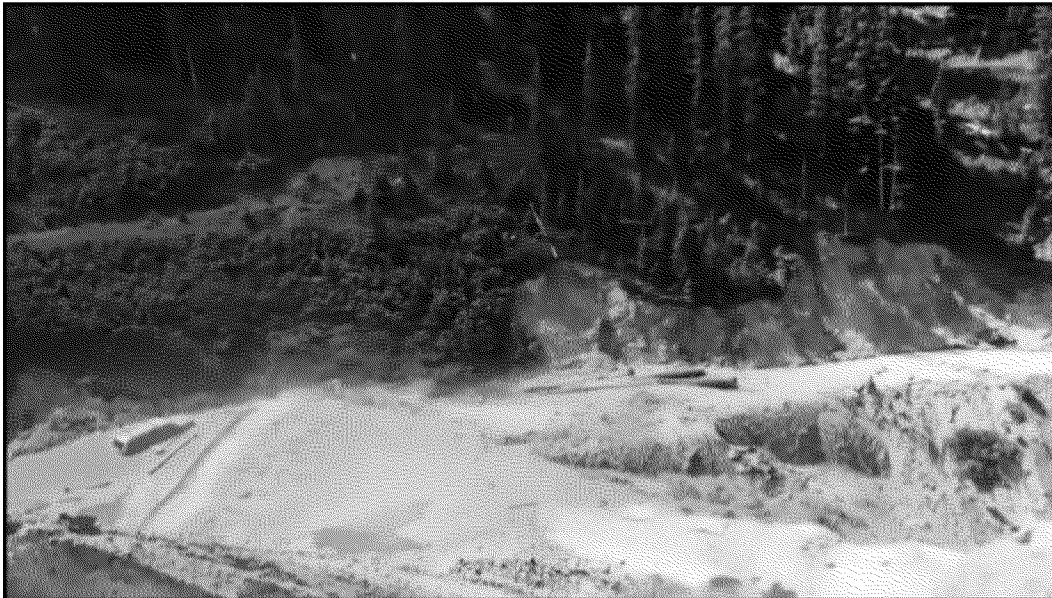
Figure 56.—Photograph showing at left, the inundation of a vehicle parked near the base of the waste-rock dump, and on the right water overwhelming the access road and cascading down into the North Fork of Cement Creek (still frame extracted from a video taken on August 5, 2015, at approximately 10:57 a.m.).

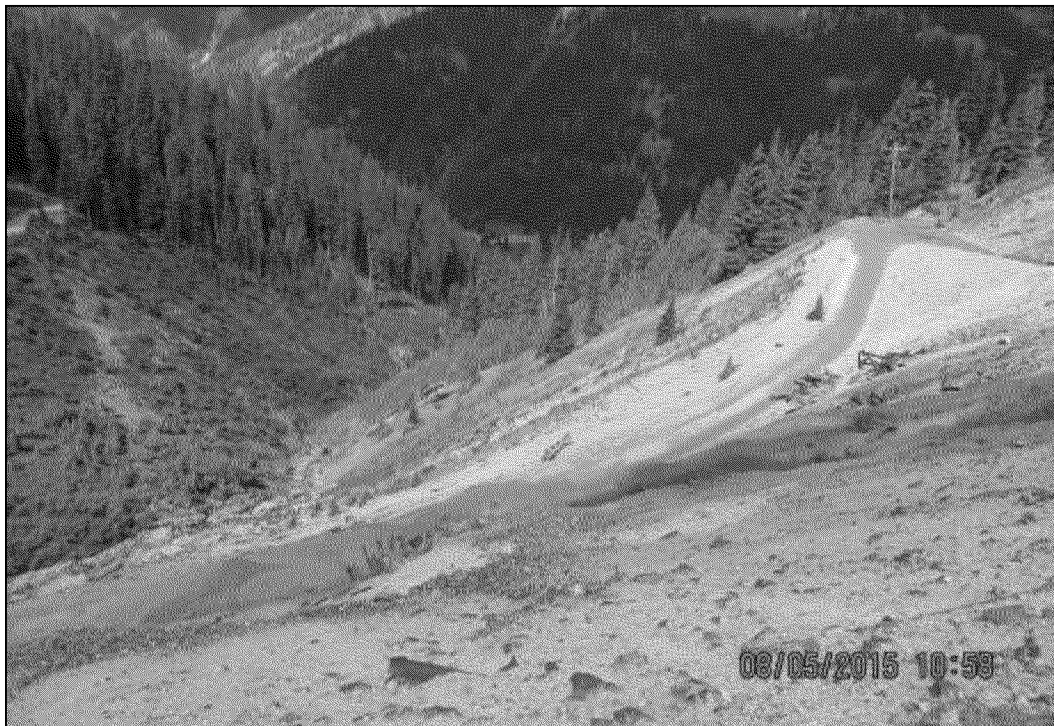
Figure 57.—Photograph showing a portion of the mine water flowing down the access road at 10:58 a.m. on August 5, 2015 (photograph from EPA project files).

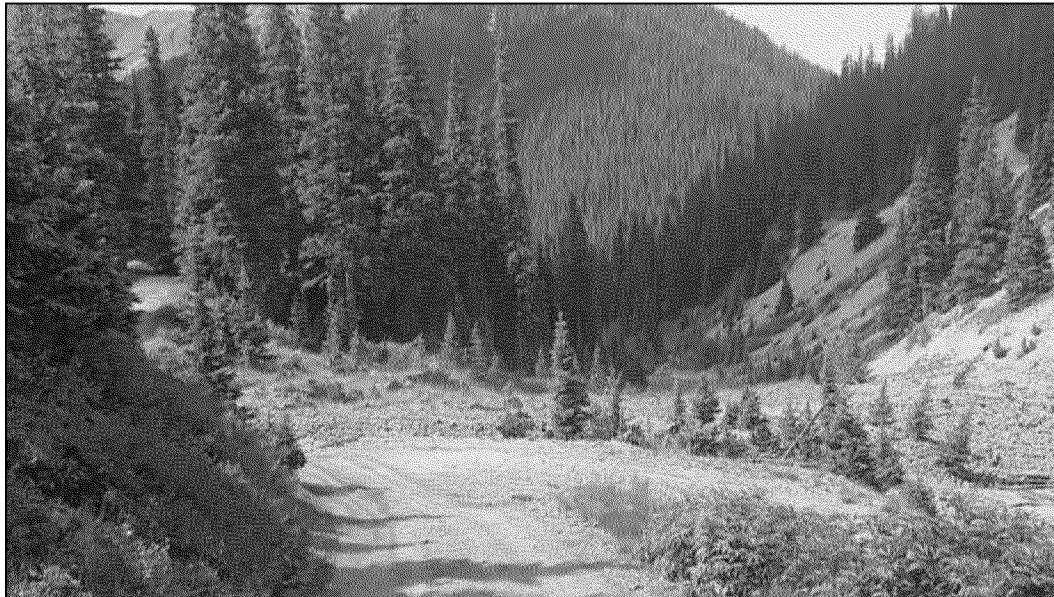
Figure 58.—Photograph looking south along the lower road and Cement Creek showing the blowout flow surging across the lower road and overwhelming Cement Creek (still frame extracted from a video taken on August 5, 2015, at approximately 11:00 a.m.).

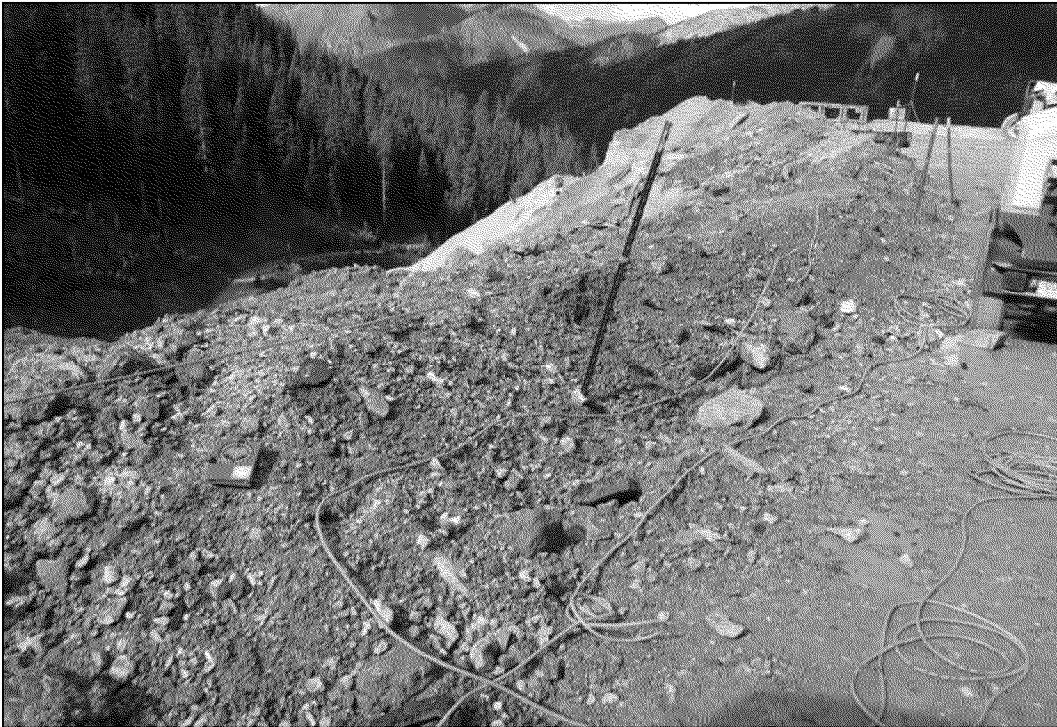
Figure C-1.—Photograph showing the safety berm made of soil that was excavated from in front of the Gold King Mine Level 7 New Adit portal. Sample No. 1 consisted of soil sampled from various locations along the safety berm.

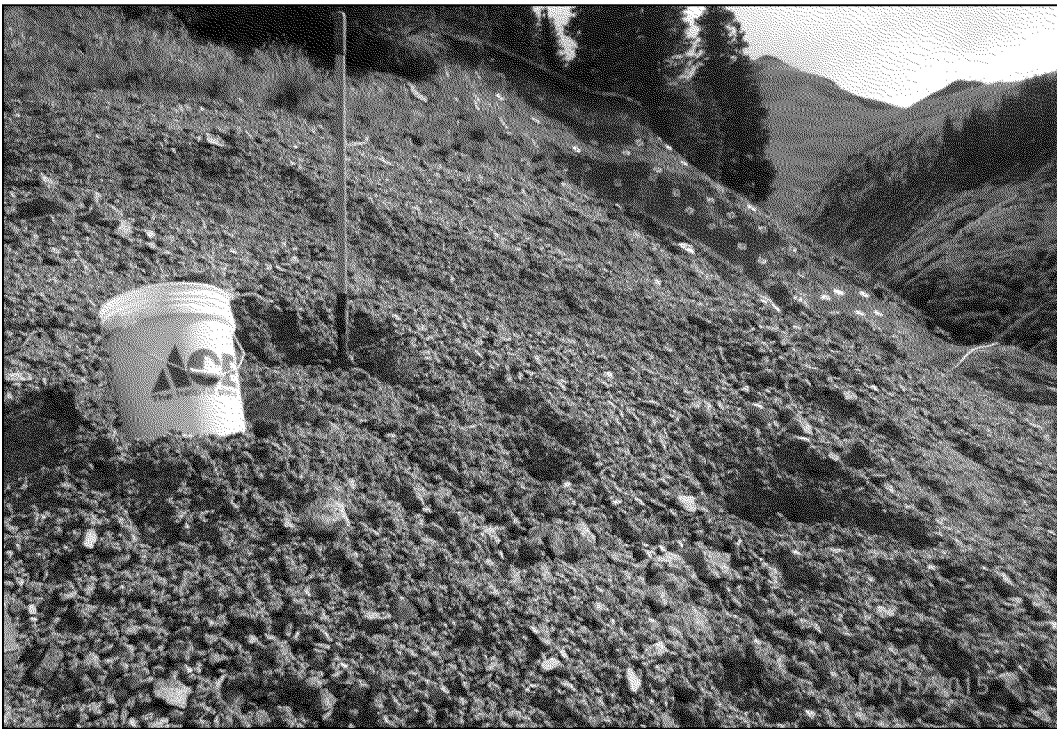
Figure C-2.—Photograph of stockpile where Sample No. 2 was collected. The rock anchors supporting the Gold King Mine Level 7 portal can be seen in the background.

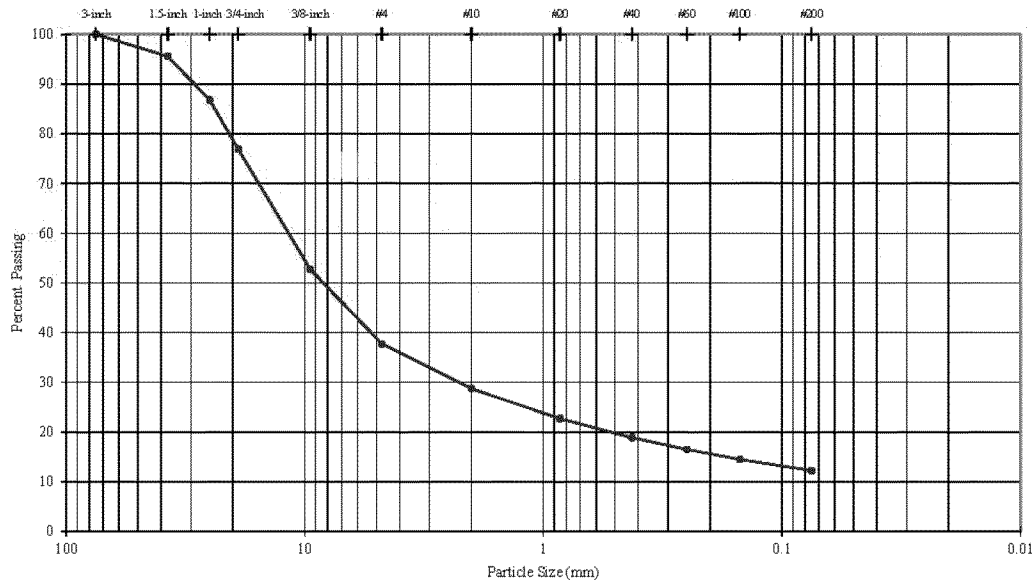
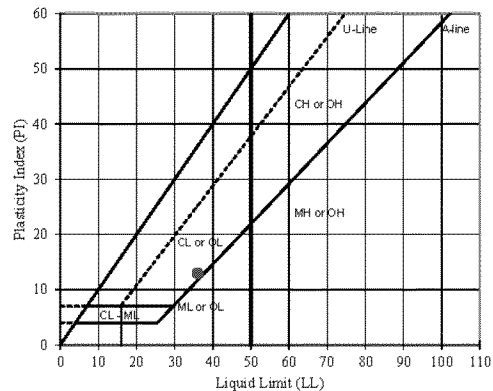
PROJECT NAME: USBR/Lab Testing - 2014/CO
SAMPLE ID: #2
TYPE: Pail

Visual Description:
Clayey gravel with sand, yellowish brown, moist

LL	PL	PI
36	23	13
